Parliamentary  
Library

2002/10 06 November 2002

## Leaky buildings

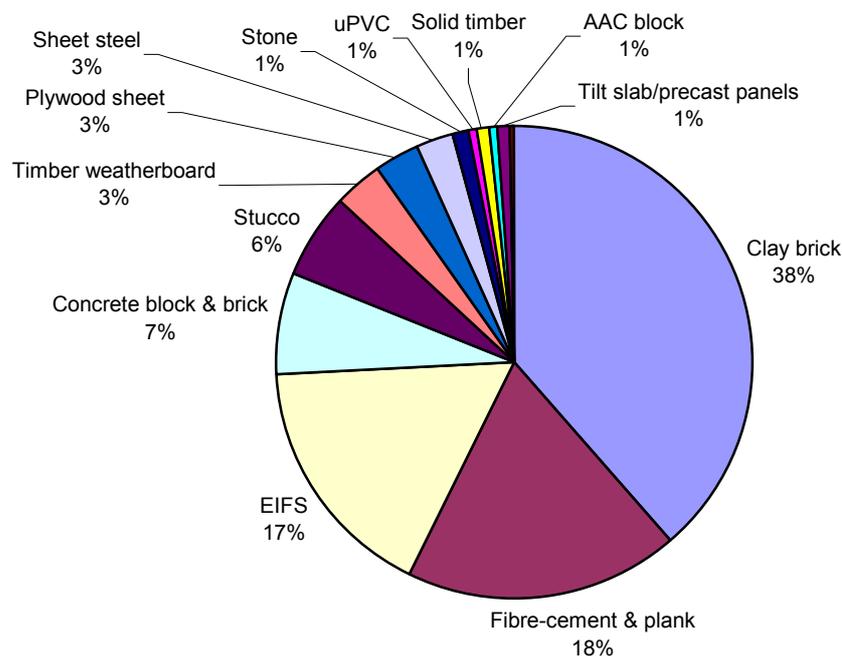
**Figure 1. Cladding types used in new dwellings, year ended 31 December 2001.** Source: BRANZ, August/September 2002. "Cladding types in use today", pp. 6-7. Note: EIFS is coated polystyrene and includes polystyrene slabs attached to timber framing and concrete-filled polystyrene blocks.

The use of cladding materials has changed quite remarkably over the last 40 to 50 years. For those houses built prior to the 1960s, approximately 60 percent used weatherboard, with the remainder mainly using brick veneer and stucco. Nowadays, a range of cladding products is in use within the building industry. According to a recent BRANZ survey,<sup>50</sup> brick veneer is used in about 39 percent of new dwellings, while timber weatherboard is used in approximately three percent of new dwellings. Fibre-cement sheets now make up approximately 19 percent of cladding used on new dwellings, while Exterior Insulation and Finish Systems (EIFS) cladding materials are used on 17 percent of new dwellings. Figure 1. below details the cladding types used in new dwellings for the year ending December 2001.
